The Seven Deadly Sins of Construction Problems

Data shows builders should watch out for these most common causes of construction problems.

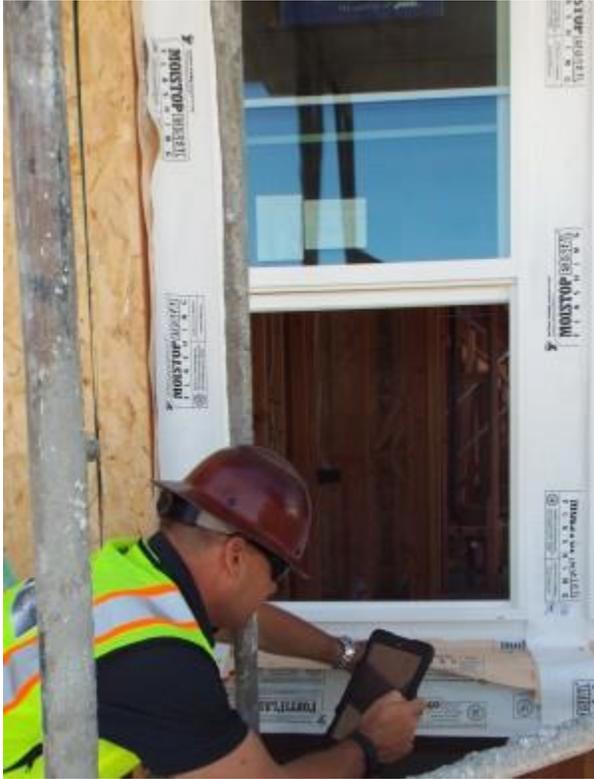
production homes). Similarly, open gaps at flashing joints and lack of storm collars on plumbing penetrations through the roofing assemblies are also water sources.

- 1. Improperly designed and constructed roofs.** Water leakage from any source can result in unhealthy living conditions due to mold growth and damage to interiors. Clipping eaves as a design solution to save construction costs is not recommended as the eaves help protect the walls. In turn, flat roofs with decks over living spaces—functioning like a walkable roof—are a potential water intrusion disaster. While many roof installation defects can be identified, the most vulnerable are out of sight and create longer-term deterioration. These include roofing felt that is not fully covering the roof sheathing or is split, torn, or deteriorated from overexposure. That mistake can create an entry point allowing water intrusion or pigeons in the attic (yes, we have had first-hand experience of pigeons roosting in attics of newly built and homeowner-occupied

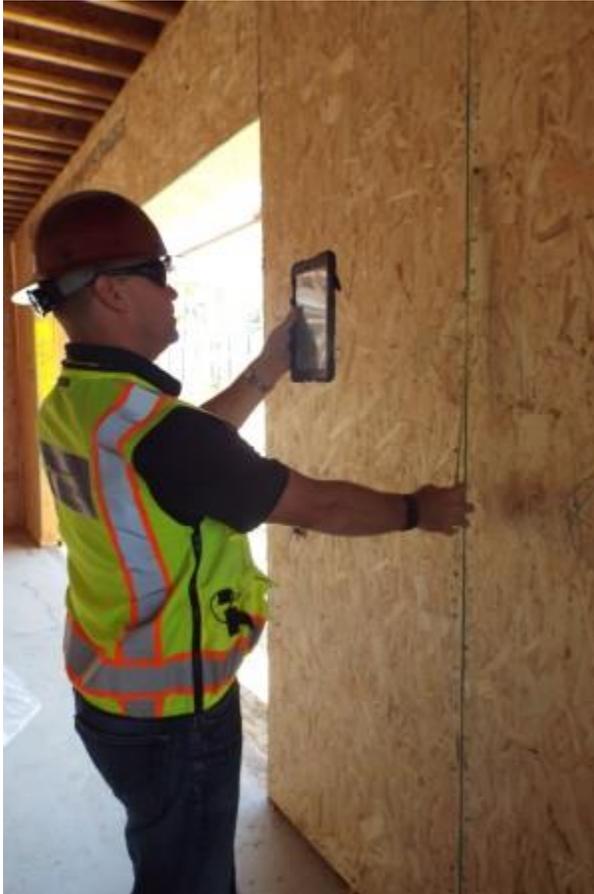
Poorly drawn plan details or missing saddle-flashing of cantilevered structural supports can result in rotting structural members.

3. Improperly designed and built decks or balconies. Safety is a critical issue in balcony design and construction—whether for a two-story wood-frame structure in Los Angeles or a 60-story concrete/steel high-rise in Miami. Positive drainage seems to be an ever-present challenge due to lack of sufficient slope on the decks. Water intrusion may occur when a balcony or deck is framed with minimal slope or sloped toward the wall plane rather than away from the wall and structure. This can further result in moisture intrusion and wood rot problems. Similarly, improper installation of drains can be a contributing factor. Water testing of completed deck assemblies is always recommended. Ensuring that decks and balconies are structurally sound is critical.
